Manhole Inspection Summary

Manhole # S51O__019MH

Insp Date: **4/23/08 11:35 AM**

Location Address: **1001 south lakewood avenue** Cross Street: **odonnell street**

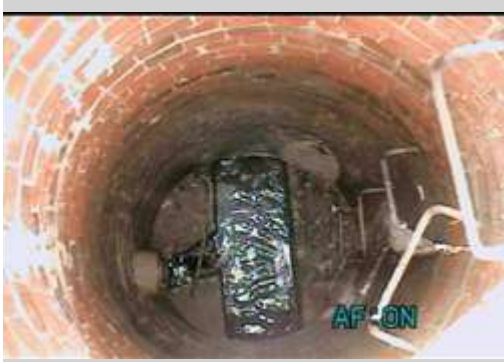
Defect 1

Steps Count: **9** Missing: **0** ☒ **Corroded**

Surcharge ☒ **Evidence Of Surcharge** Depth: **5** (ft.) ☐ Active Surcharge Present

steps corroded & surcharge evidence

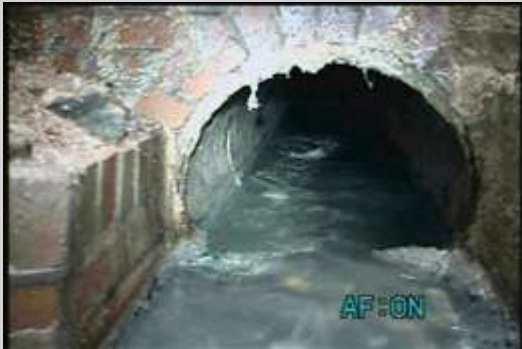
12 O'Clock Outflow

8 in. Circular Gravity Sewer
Pipe Out @ 12 O'Clock

Pipe Material: **Clay** ☐ Pipe Lined

Invert Depth: **14.50** (ft.) Flow Characteristics: **Fast**

Deposits: ☒ None ☐ Mud ☐ Gravel ☐ Debris ☐ Grease

Infiltration: **None** Pipe Seal Cond: **Unknown**

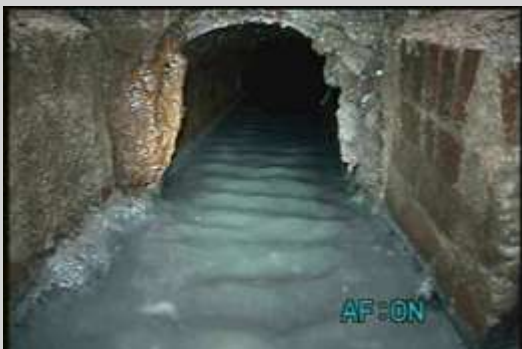
6 O'Clock Inflow

8 in. Circular Gravity Sewer
Pipe In @ 6 O'Clock

Pipe Material: **Clay** ☐ Pipe Lined

Invert Depth: **14.20** (ft.) Flow Characteristics: **Fast**

Deposits: ☒ None ☐ Mud ☐ Gravel ☐ Debris ☐ Grease

Infiltration: **None** Pipe Seal Cond: **Unknown**

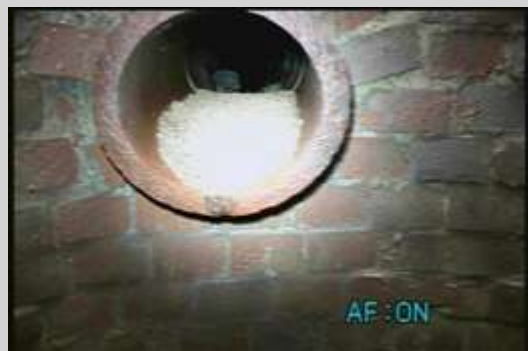
Pipe In @ 9 O'Clock

8 in. Circular Gravity Sewer

Deposits: ☐ None ☐ Mud ☒ Sludge ☐ Debris ☐ Grease

Silt Depth: 4 (in.) Deposits Extent: Medium

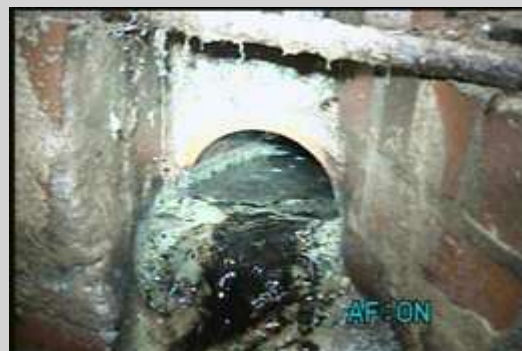
Drop In @ 9 O'Clock

Drop: Outside Direct

Inv Depth: 13.30 (ft.)

Drop Condition: Open
